FIRE IN U.S. ARMY HELICOPTER ACCIDENTS

1 JULY 1957 THROUGH 30 JUNE 1965

By
Emil Spezia

Report No. HF 67-1

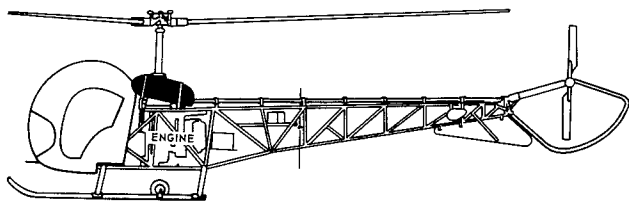
FIGURE 2

During the eight years this report covers, the fuel system of the OH-13G and H demonstrated the least resistance to failure during crashes. This observation helicopter, which has been one of the mainstays of Army operations, accounted for 38% of the survivable post-crash fire accidents. Its main design deficiency is the unprotected location of its twin fuel tanks (see Figure 2).

OH-13 Models G and H Twin Fuel Cells

The survivable fire accident rate of the OH-13G and H over the years has been five times that of the D and E. In 91% (32 of 35) of the survivable fire accidents shown on Table 3, fire was due to a rupture or puncture of the fuel tanks or fuel lines. Added fuel capacity, needed for the D and E to grow into the higher performing G and H, required larger tanks. The change resulted in the design decision to install twin tanks with a combined capacity of 43 gallons. This new location was needed for the enlarged tanks because it would least affect the helicopter's center of gravity (see Figure 2). The enlarged twin tanks in this location, saddled on each side of the rotor mast above the engine, crowded the available protective space the airframe gave to the D and E tank. Because of their enlarged size, the twin tanks were moved nearer the rotor mast and

were often punctured by the swash plate when the mast became displaced during a crash. Larger dimensions also caused the tanks to extend beyond the protection of the airframe, which makes them among the first parts of the aircraft to strike the ground. In the event of roll-over, which is characteristic of a helicopter accident, the twin tank configuration always leaves one tank atop to leak fuel. This point is illustrated by the following excerpts of statements given in two accidents:

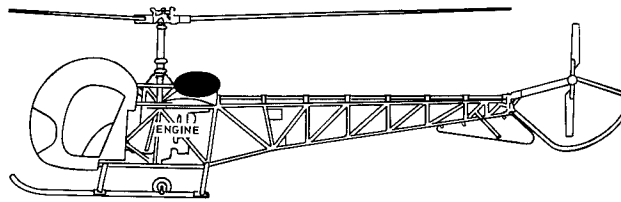
FIGURE 3

OH-13 Models D and E Single Fuel Cell

The reason for the OH-13D and E low rate, now that it can be compared with the G and H, is believed to be due to its single 29-gallon tank, mounted above the engine and aft of the rotor mast (see Figure 3). In this location, the tanks are relatively well protected from rupture and puncture damage. However, Table 3 shows that in five of its six fire accidents, either the tank or the adjoining fuel lines failed to prevent fuel spillage. This fact points out that this location is still not ideal, because, when fuel is spilled, it has quick access to the many ignition sources available about the engine.

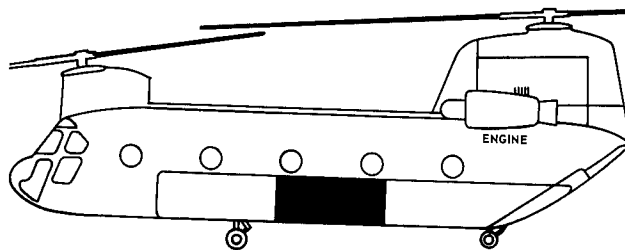
FIGURE 7

Similar design practices are found in the UH-19, CH-21, and CH-47. In the Chinook (CH-47), however, this combination of features is somewhat better (see Figure 7). The fuel cells, though located below floor level, can be penetrated by the rear landing gear, but are some distance from the engines which are mounted on each side of the aft rotor pylon.

CH-47 Fuel Cells Remote From Engine Area

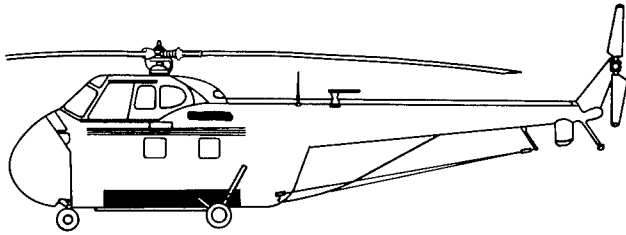
FIGURE 9

UH-19 Fuel Cell Location in Relation to Landing Gear and Engine Area

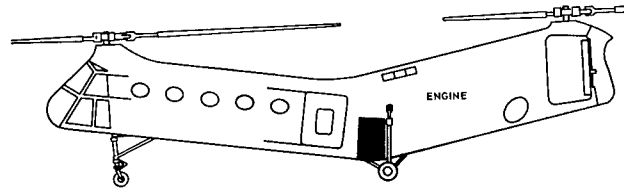
FIGURE 10

CH-21 in Relation to Landing Gear Fuel Cell Location and Engine Area
